NASA Technical Paper 1834

Some Effects of Thermal-Cycle-Induced Deformation in Rocket Thrust Chambers

Ned P. Hannum and Harold G. Price, Jr.

APRIL 1981

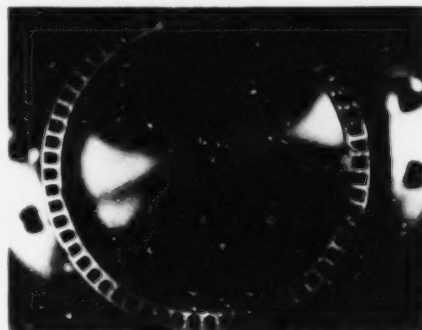
Figure 6. - OFHC copper thrust chamber 74, typifying failure site and deformation of hot-gas-side wall.

The crack sites were generally characterized by a thinning and bulging of the hot-gas-side wall. Also, there was a roughening of the hot-gas-side wall, especially in the throat region of the thrust chamber. Figure 6(a) is a view of the hot-gas-side wall showing the general surface roughening of OFHC copper chamber 74. A 3.5-centimeter (1.4-in.) long crack at the centerline of a coolant channel can also be seen. A post-test inspection of all the chambers tested revealed that the roughening was more severe with the OFHC copper than with the Narloy-Z and the heat-treated Amzirc. Also, the roughening was more severe in the throat region, where the temperature was higher than at other locations in the combustion chamber.

A cross section, at the throat, of an entire thrust chamber is shown in figure 6(b). This is OFHC copper chamber 74, which had the low-stiffness closeout described in the Apparatus section. The fiberglass portion of the closeout has been removed. It can be seen in figure 6(b) that the deformation is not the same in each of the 60 coolant channels. The circumferential location of the most severe deformation seems to be random, that is, not related to injector patterns, cooling manifolds, or fabrication anomalies that are within the drawing specifications.

(a) View of hot-gas-side wall showing typical crack through wall just upstream of throat.

(b) Cross section of throat plane showing 60 cooling channels and electroformed closeout.

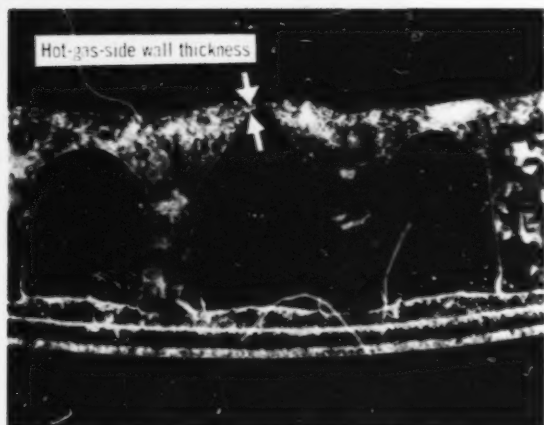
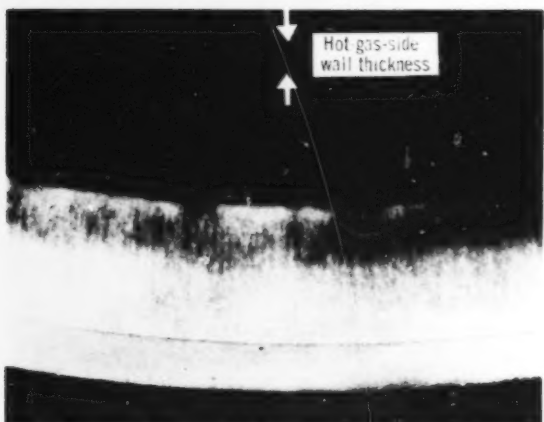
Figure 7. - Cross-sectional view of failure sites.

Cross-sectional views of the failure sites for two different materials are shown in figure 7. The failed

coolant channel is characterized by a "doghouse" shape and a bulge of the hot-gas-side wall toward the centerline of the thrust chamber. Conservation of the wall material was assumed since no hot-gas-side surface melt or erosion was observed. The hot-gas-side wall must thin therefore to accommodate the bulge. Because of the progressive thinning a valley tends to form at the center of each bulge to form two bumps per cooling channel. It can be seen in figure 7(a) that much greater bulging and thinning occurred with the OFHC copper material than with Narloy-Z (fig. 7(b)). The failure sites for the other thrust chambers (not shown) also had the doghouse shape. Although all materials deformed similarly, an important difference is evident between the two failure sites shown in figure 7. In addition to the thinning of the hot-gas-side wall, a necking of the material in a small region on each side of the failure site occurred with the OFHC copper. This is the typical appearance of a tensile failure with a ductile material. Tensile failures were observed in reference 4 for OFHC copper, heat-treated Amzirc, and Narloy-Z. The failure mechanism was described as stress rupture. In the present work the failure site

(a) OFHC copper thrust chamber 75.

(b) Narloy-Z thrust chamber 150.

shown for Narloy-Z in figure 7(b) does not show necking of the material adjacent to the crack. Therefore the visual evidence in the present work supports the reference 4 contention of a tensile stress failure mechanism only with OFHC copper. The failure sites of the Narloy-Z and heat-treated Amzirc in the present work are different than those observed in reference 4 because there is no evidence of necking adjacent to the crack with these materials. The failure mechanism for Narloy-Z and heat-treated Amzirc appears therefore to be more fatigue related.

Some metallographic observations were made of the material at the failure sites. It appears that some recrystallization has occurred in the hot-gas-side wall of OFHC copper chamber 75 (fig. 7(a)). No recrystallization was observed for the other materials. When hardness surveys were taken across sections similar to those shown in figure 7, it was found that the hardness adjacent to the failure site was different from the hardness away from the failure site (near the electroformed closeout). If it is assumed that the liner material away from the failure site remained in the pretest condition, then a change in hardness must have occurred at the failure site for all the liner materials during cyclic testing. Hardness measurements for each chamber are given in table I. The as-fabricated hardness with OFHC copper was R_B 12 to 15. At the failure sites there was softening

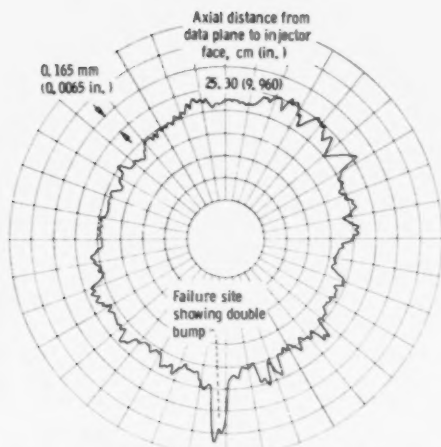
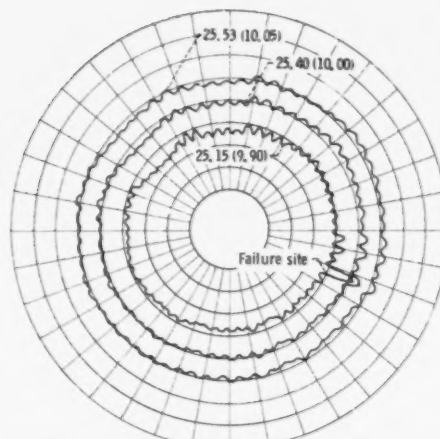
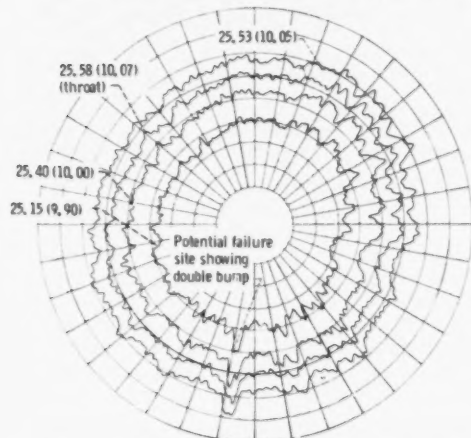
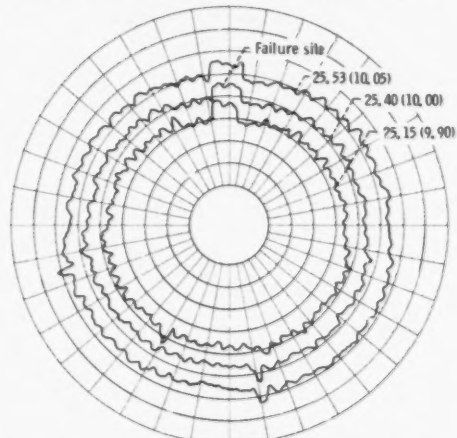
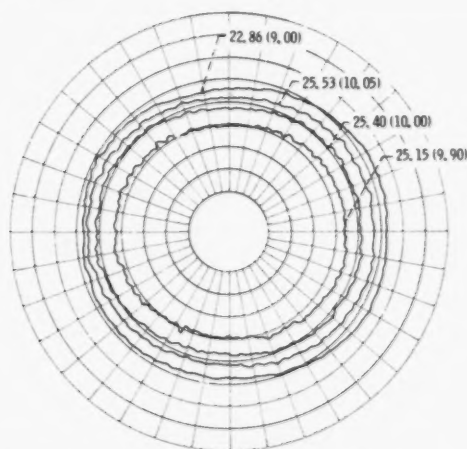
Polar plots were made for each of the thrust chambers to document the post-test hot-gas-side wall deformation. The hot-gas-side wall deformation for OFHC copper chamber 74 is presented in figure 8(a). The failure site and one or two other channels exhibit the double-bump characteristic. (Each cooling channel covers a 6° arc.) The deformation at the failure site is much greater than that at other locations in the thrust chamber. This was true for all materials, as shown in figure 8(c) for Narloy-Z chamber 140 and in figure 8(d) for heat-treated Amzirc chamber 82. The deformation data from these polar plots are tabulated in table I. Deformation at the failure site was defined as the distance from the valley (at approximately the rib centerline) to the largest peak. The data tabulated were for the largest observed hot-gas-side wall deformation measured from plots such as figure 8(a).

(a) Postfailure data for OFHC copper thrust chamber 74 after 193 cycles.

(c) Postfailure data for Narloy-Z thrust chamber 140 after 301 cycles.

(b) Intermediate-life data for OFHC copper thrust chamber 74 after 124 cycles.

(d) Postfailure data for heat-treated Amzirc thrust chamber 82 after 250 cycles.

(e) Intermediate-life data for heat-treated Amzirc chamber 82 after 99 cycles.

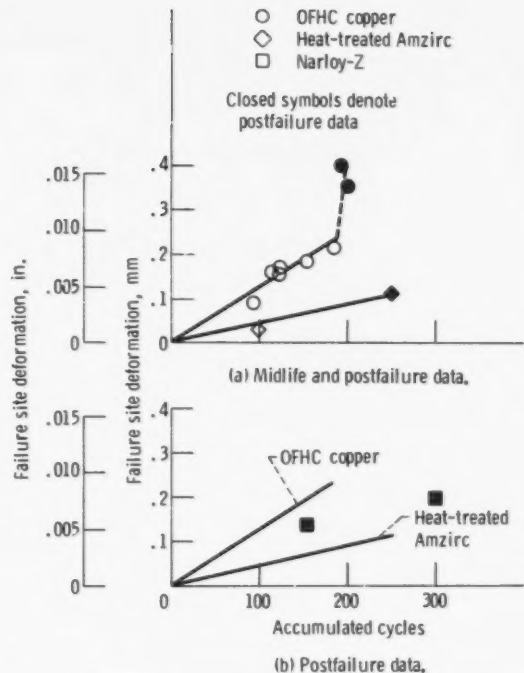
Figure 9. - Failure site deformation as a function of accumulated cycles for three different thrust chamber liner materials.

The failure site deformation data for the two OFHC copper chambers (serial numbers 74 and 75) and for the heat-treated Amzirc chamber (serial number 82) are presented in figure 9(a) as functions of accumulated cycles. Where available, data taken with both nondestructive methods, that is, plaster cast segments and full 360° plots, are shown. The closed symbols are the postfailure points and represent an average of the nondestructive and the postfailure photographic data. Even as the deformation becomes large, the failure site bulges out into the chamber in a nearly linear manner as cycles are accumulated. Reference 5 has characterized the failure mechanism as a ratcheting type of process. The slope of the deformation histories presented in figure 9 could be considered a ratcheting rate. The ratcheting rate is nearly three times greater for the OFHC copper than for the heat-treated Amzirc. As noted in the Apparatus section, the structural jackets for the OFHC thrust chambers

As shown by the dashed line in figure 9(a) there was a rapid increase in the hot-gas-side wall deformation just before failure with the OFHC copper chamber. At the onset of failure the material no longer ratchets linearly but becomes unstable and rapidly deforms (thins) until a tensile stress failure occurs. This was seen visually in the cross-sectional photograph (fig. 7(a)) as local necking of the material adjacent to the crack. The rapid deformation and thinning may have occurred in the final cycle or progressively during the last nine cycles.

As was stated earlier the cross-sectional photographs of the heat-treated Amzirc and the Narloy-Z failure sites did not indicate local necking of the material adjacent to the crack. The postfailure deformation data for the two Narloy-Z thrust chambers are shown in figure 9(b) along with the deformation histories for the OFHC copper and heat-treated Amzirc chambers presented above. A single deformation rate curve could be used for both Narloy-Z chambers but with failure occurring at different points.

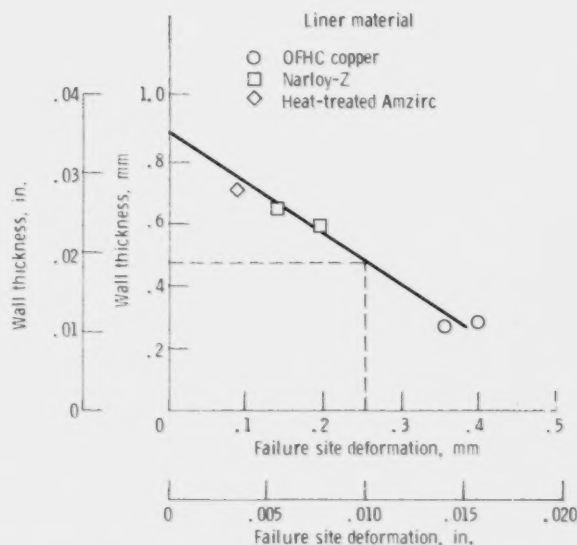
Figure 10. - Failure site deformation as a function of coolant channel wall thickness for three different thrust chamber liner materials.

The final failure site deformation as a function of the final failure site hot-gas-side wall thickness is shown in figure 10 for three different thrust chamber materials. The data were obtained by measuring cross-sectional photographs. The definition of deformation was the same as that used with the polar plots (fig. 8). The wall thickness was measured as indicated in figure 7. As shown in figure 10 the wall-thickness-versus-deformation data are correlated by a straight line that extrapolates to the original wall thickness of 0.899 millimeter (0.035 in.) for zero deformation. Although this correlation was made from postfailure data, it is assumed that the correlation is also valid at intermediate life. Use of this correlation provides a means for determining wall thickness at intermediate-life points from measurements of hot-gas-side wall deformation.

For example, the use of the correlation between hot-gas-side wall deformation and thinning made it possible to estimate the wall thickness for the OFHC copper at the onset of failure. By extrapolating the OFHC ratcheting rate curve (fig. 9(a)) to 200 cycles it can be seen that at the onset of failure the deformation was approximately 0.25 millimeter (0.010 in.). Figure 10 shows that a 0.25-millimeter (0.010-in.) deformation corresponds to a wall thickness of 0.475 millimeter (0.0187 in.).

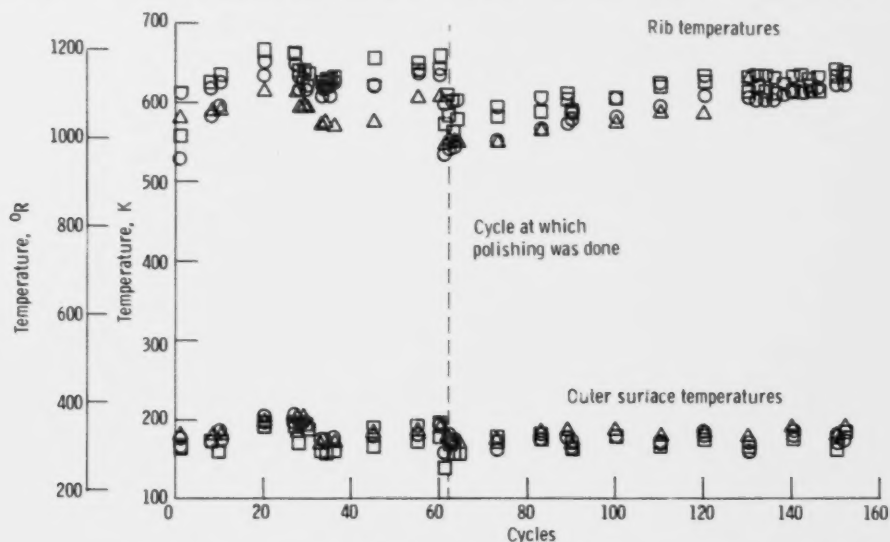
Figure 11. - Effect of polishing hot-gas-side wall surface on wall temperatures - OFHC thrust chamber 70.

the hot-gas-side wall temperature. Increases in the measured rib temperature (fig. 11), the coolant pressure drop, and the coolant temperature rise (fig. 12) were reported for an OFHC copper chamber with a thick electroformed nickel closeout similar to the Narloy-Z chambers in the present work. The roughening progressed and the temperatures increased as 60 cycles were accumulated. In an attempt to link the surface roughening effect to the increasing temperature effect the hot-gas-side wall was polished with a fine-grit emery paper by rubbing only in the axial direction. The effect of this

polishing can also be seen in figures 11 and 12. The average rib temperature for the sixty-first cycle was approximately 83 K (150 deg R) less than that for the sixtieth cycle. Similar changes can be seen in other parameters. The polishing did not remove the deformation (bulging of the coolant channel) but instead restored the surface finish to approximately the original condition. The resumption of cyclic testing again caused the temperatures to steadily increase. After the chamber had been tested for a total of 153 cycles the hot-gas-side surface roughness (in the axial direction) was measured. The roughness was 230×10^{-6} to 760×10^{-6} centimeter rms (90×10^{-6} to 300×10^{-6} in. rms).
